U.S. ARMY
H-25 HELICOPTER DROP TEST
22 October 1960

TREC
Technical Report 60-76

AvCIR 2-TR-125

March 1961

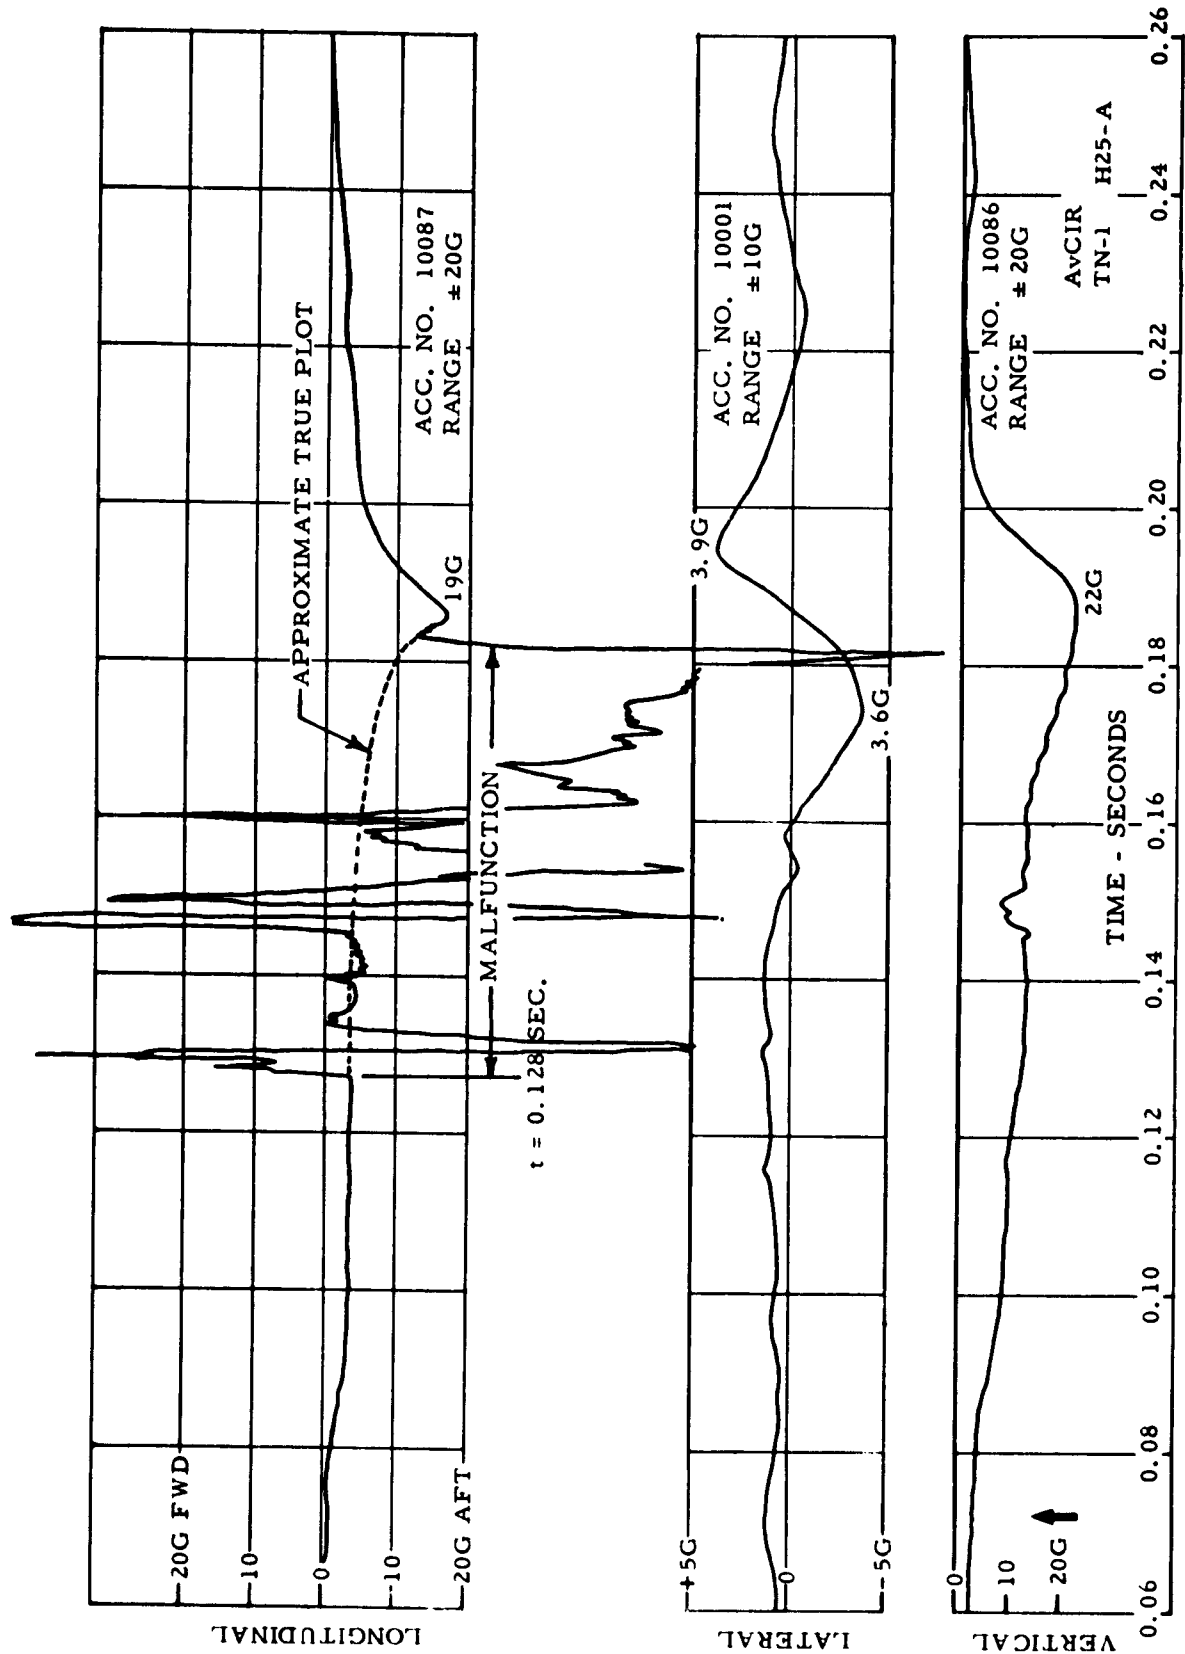
Figure 31. Accelerations of Airborne Instrument Package

Acceleration of the airborne package exceeded the design value of 14.5G at 0.19 second as may be observed in Figure 31. The results obtained from the airborne recorder are thus considered doubtful, pending further analysis of the data. The two channels of airborne data presented in Figure 38 (range extender tank seat belt and shoulder harness) are accurate to 0.13 second and are significant beyond this time in that the indicated loads in these belts are low.

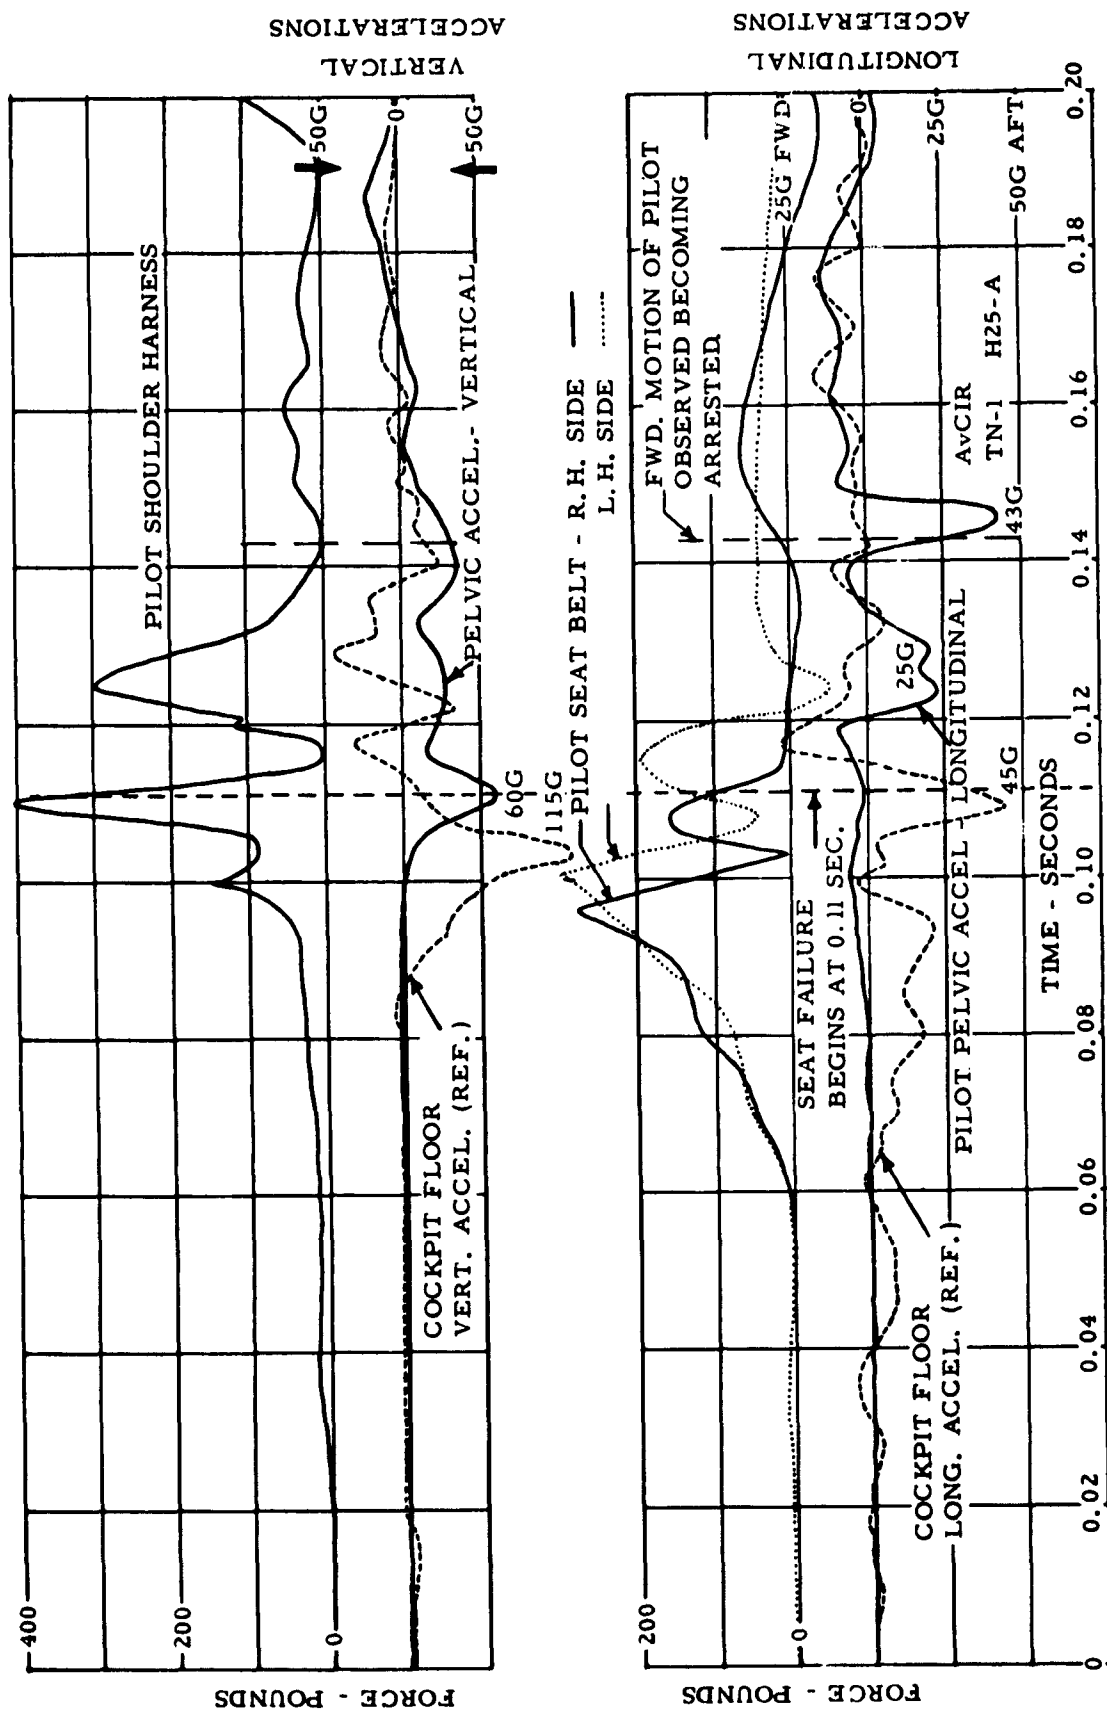
Figure 34. Pilot Shoulder Harness and Seat Belt Loads and Pelvic Accelerations

A study of Figure 34 shows that the peak longitudinal and vertical accelerations observed at the floor level were carried through to the pilot dummy pelvic-region with a time delay of approximately 10 milliseconds. There was, approximately, a 50 percent reduction in amplitude of the main pulse in each case, but with a corresponding increase in time duration as would be anticipated. In fact, the pelvic vertical acceleration was maintained at an average value of about 30G for some 0.040 second, accounting for a change in velocity of 39 f. p. s. in this interval.

The time of failure is seen from Figure 34 to correspond with a sudden reduction of load in the shoulder harness (as would be expected since the shoulder harness is attached to the seat structure in the H-25A aircraft) and with the peak pelvic vertical acceleration 60G. The seat continued to rotate (Figure 41) until 0.143 second, at which time a very abrupt reduction in the forward

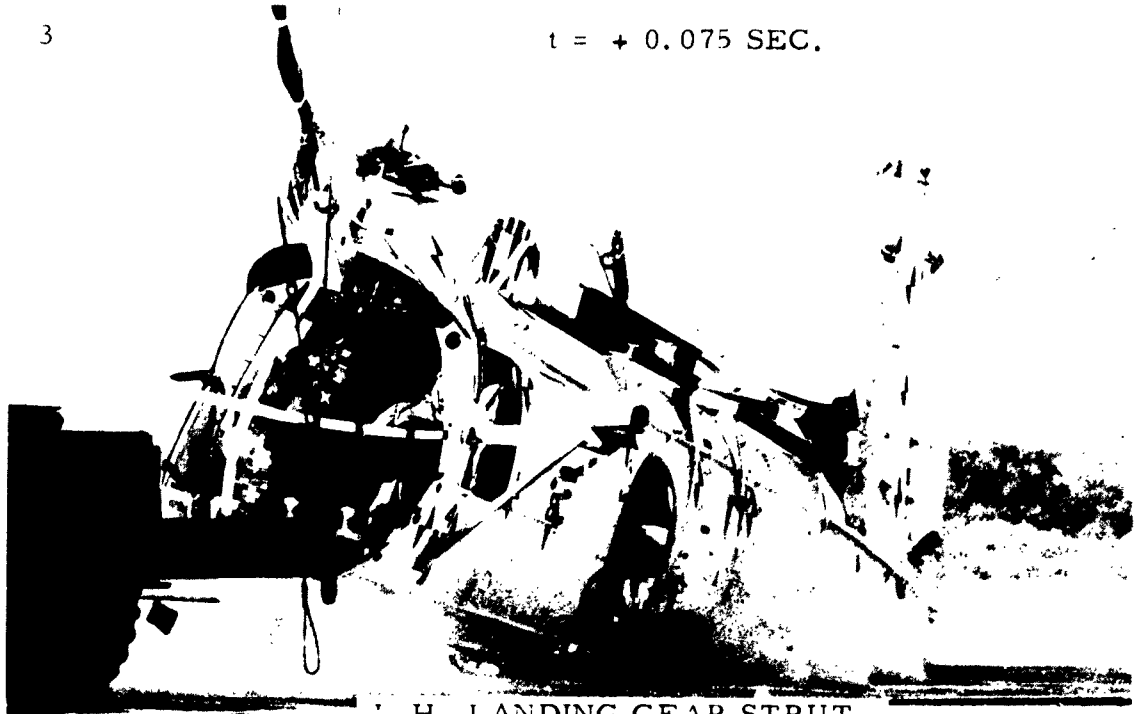
Figure 40-3. Sequence Photograph, H-25 Drop Test

L. H. LANDING GEAR STRUT
PUSHES THROUGH FUSELAGE

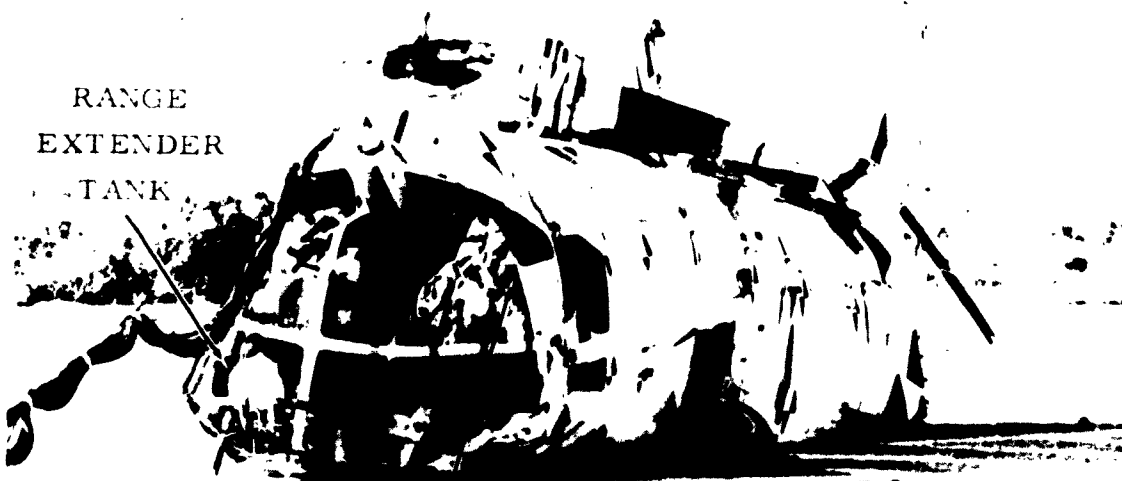
Figure 40-8. Sequence Photograph, H-25 Drop Test

POST CRASH

RANGE
EXTENDER
TANK

FUEL

PILOT'S HEAD AGAINST STRUCTURE
